Consultant's Corner

At the Breaking Point

Working with Poured-and-Debridged Thermal Breaks

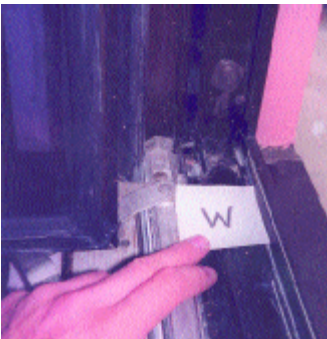
Figure 1: Shrinkage of poured-and-debridged thermal break at frame corner.

A few years ago our company became involved in a project in South Florida that included new casement windows. Within three years of the building's completion water leakage was observed below the windows we were asked to investigate. While selecting a specimen for testing, we noted gaps in the corners of the frames at the thermal breaks. Inspection revealed contraction of the thermal break at approximately 70 percent, of the windows creating gaps of up to ½ inch (see Figure 1). During our review of shop drawings we noted the subcontractor had provided the poured-and-debridged thermally broken windows although they were not specified.

The window manufacturer was very quick to respond and sent mechanics to clean and seal all of the frame corners. At the fixed windows, interior-glazing beads were removed to provide access to the frame corners and in many cases were damaged and replaced with new ones. The failure was attributed to the high heat and humidity in South Florida.

1. Is a thermal break necessary?
Eliminate them if possible, especially in hot climates.
2. The Iso-Bar system is less prone to heat shrinkage and is recommended for use in hot climates.
3. For poured-and-debridged thermal breaks, avoid polyester-based polyurethane, which is not recommended for wet/high-moisture conditions. Testing of polyether-based polyurethanes shows they are not affected by moisture and have increased heat stability.
