### Using physical mockups to identify curtain wall design flaws

Mark Baker, president, IBA Consultants -- 9/16/2009 1:14:00 PM

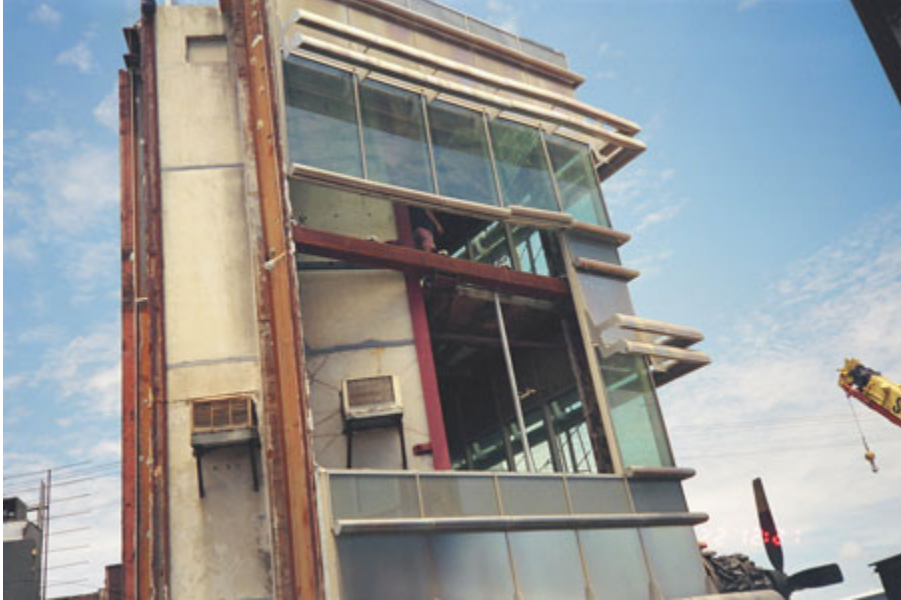
A recent mockup test found design and manufacturing flaws in this curtain wall system

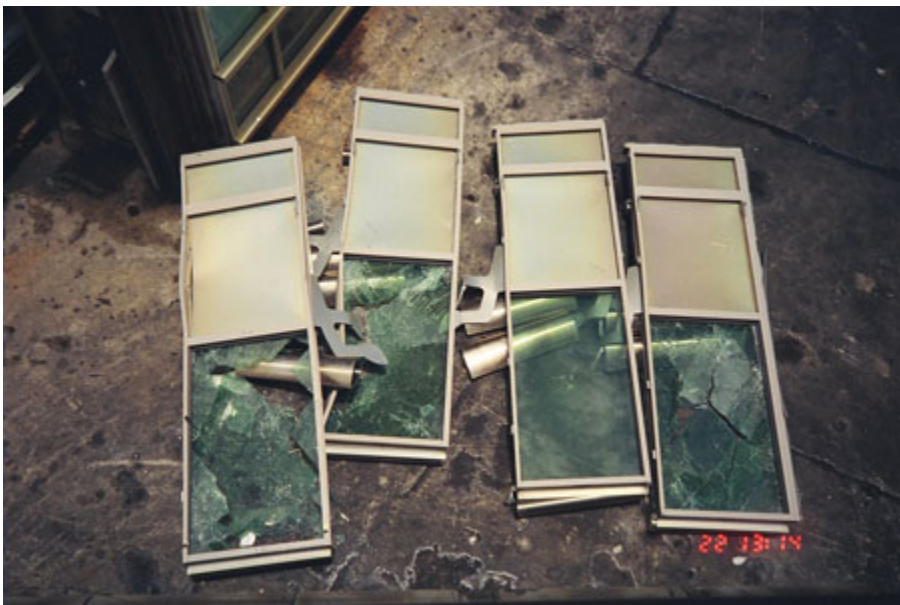
After satisfactorily passing static pressure air infiltration testing, static pressure water penetration resistance testing, dynamic pressure water penetration resistance testing, and inter-story differential movement testing, the mockup was subjected to positive and negative structural load tests. During the structural load tests, a section of the curtain wall's anchorage failed when subjected to a negative load of -2.5 kPa (-52 psf)—simulating suction forces caused by wind. The end result: four unitized curtain wall frames separated and fell to the ground from the second floor.

During onsite tests, unitized curtain wall frames failed when exposed to negative loads.

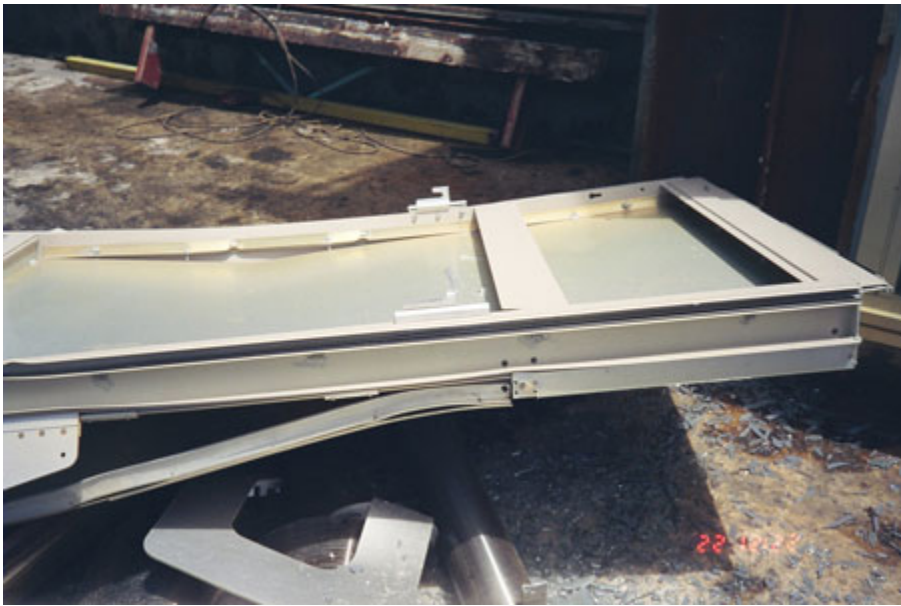
While it was noted that several of the supporting hooks had failed, we also observed that not all of

the hooks had failed. Some of them had slipped off of the ends of the supporting rods that allowed the curtain wall frames to fall.

Diagnostic investigation revealed that some hooks failed while others did not.

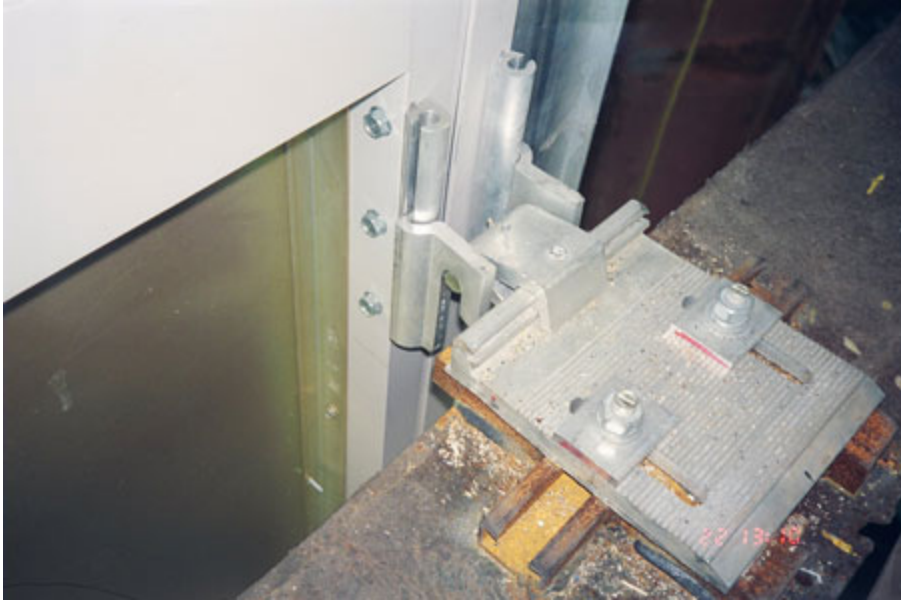
- Movement of the wall during testing allowed the anchorage hooks to slip from the supporting rod, transferring forces in excess of the design capacity to the remaining hooks, causing them to deform.
- The hooks failed prematurely under load, allowing movement of the segments, which pulled the remaining intact hooks off of the supporting rods.

Movement of hooks off the pin observed on undamaged anchors.

In addition, to address the failure of the system to prevent progressive failure, the supporting rods were redesigned. The rods were made longer and flanges were added to their ends to prevent the hooks from slipping off.

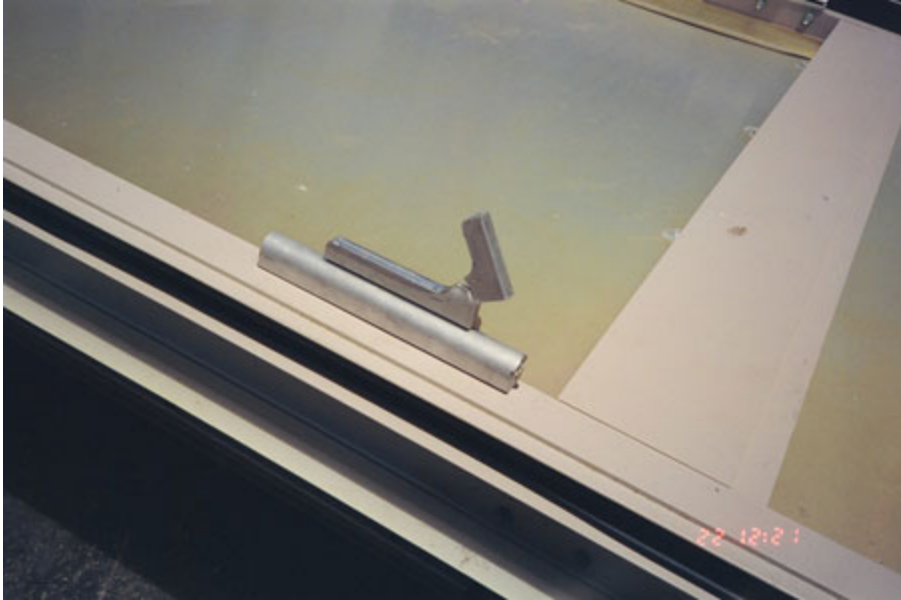
The metal hooks and rods we recovered were sent to a metallurgy laboratory to verify the alloys of the materials used for various anchor components. Lab results indicated that the aluminum alloy used for the curtain wall attachment hooks did not match the alloy specified in the curtain wall design calculations. A weaker alloy had been used by the manufacturer for unknown reasons.

Once it was confirmed that a weaker alloy was used for the curtain wall attachment hooks, we re-analyzed the loading capacity of the anchorage assembly utilizing the substituted material. Calculations confirmed that the weaker metal would have been unable to resist the loads applied to it during testing.

Deformed anchor hook – analysis would reveal that hook was manufactured using an incorrect alloy.

The curtain wall subcontractor redesigned and re-fabricated the attachment hooks using the proper alloy and replaced all of the hooks on the mock-up. The structural load test was repeated and no failure occurred.
